## 2008 HONDA FIT

Report verified by JP Center

### CONDITION SHEETS & PHOTOS

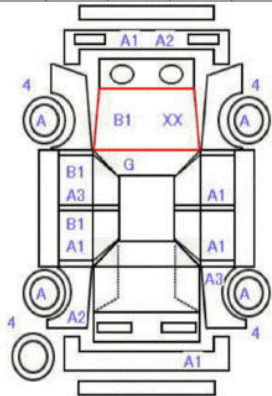
- \*特記事項\*
- AA初
  - 室内ノーマルタイヤ有(夏)
  - Fサイドメンバー凹み
  - コアサポート凹み
  - 社外AW?
  - ネジ止アッパーコア交換
  - スタッドレスタイヤ
  - バンク修理キット有
  - Fハンパーホースノット交換
  - シート 汚れ
  - シート シミ小
  - 天張 うすい汚れ
  - 外装うすい線キズ
